# Ice Dam Removal Company CASE STUDY

## ICICLES AND ICE DAMS

### The Relationship Between Ice Dams and Icicles

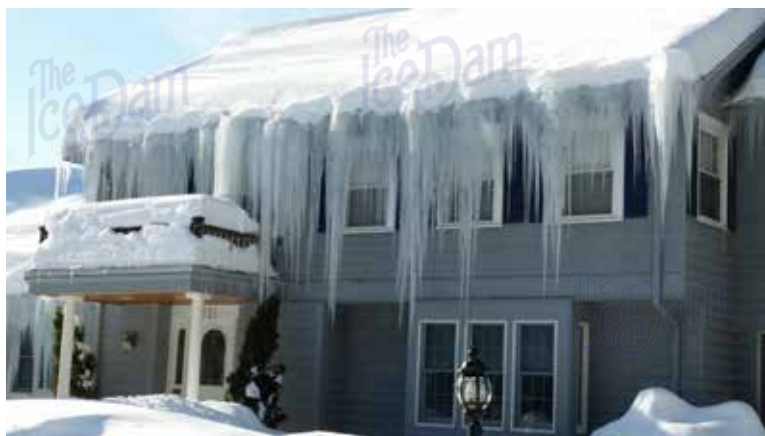
You may notice that the home shown at left has some icicles (sarcasm intended). Obviously, when something like this occurs, it is quite likely that you have ice dams as well as a giant insurance claim from the subsequent water damage it has caused. The fact is, the vast majority of the ice dam steaming projects we complete are not on homes with monster icicles. When we arrive we often see quite modest icicles from the ground. The relationship between icicles and ice dams is not difficult to understand when you study the problem for a while. This Case Study digs into the topic of icicles and ice dam life cycles.

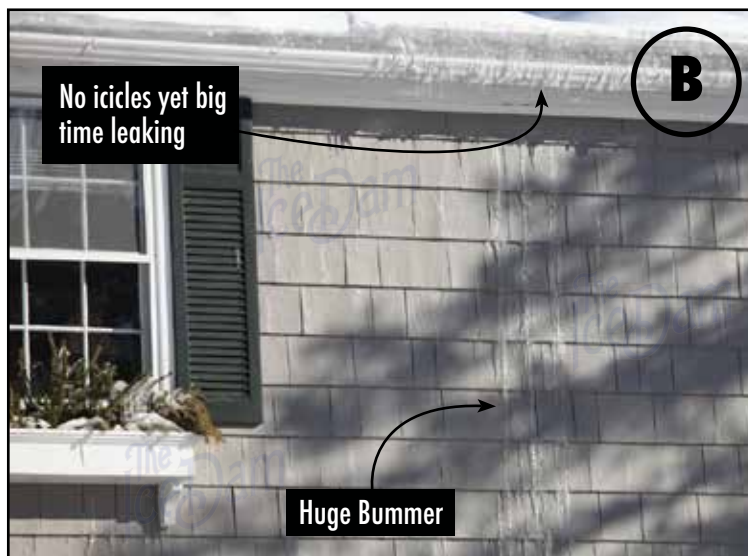
Do icicles mean ice dams? The short answer is NO. While icicles on the edge of the roof are often a precursor to ice dams, they are not always present when ice dams begin to cause leaks through a roof system. Ice dams and icicles are part of the same accumulation but they are not the same thing by any means. This brings us to the normal life cycle of an ice dam.

The characteristics of ice dams change over time. The typical lifespan of an ice dam ranges from a few days to a few weeks. During that time it may get thicker or thinner, icicles may appear and disappear on its leading edge, and it may be almost completely hidden under snow or partially or completely exposed. For this reason, there is a big difference between a young ice dam and an old ice dam in terms of the presence of icicles. Very young ice dams often have visible icicles on their leading edge. Over the following days most ice dams tend to grow more in depth than thickness, meaning the ice migrates higher up the roof plane (refer to Ice Dam Company Case Study #06 for more information). Icicles on more mature ice dams tend to melt away from the affects of direct sunlight or warmer outdoor temperatures. However, while the telltale icicles may be missing, the mass of the ice dam is left behind, frequently hidden under a blanket of snow. The photos above (A) and (B) demonstrate this phenomenon on two St. Louis Park homes. Virtually no traditional signs of an ice dam and yet you see water leaking down the exterior wall, through the siding and in the wall cavity itself. Bad news.
