# Ice Dam Removal Company CASE STUDY

# #22

## 4 COMMON SOURCES OF WINTER ROOF LEAKS

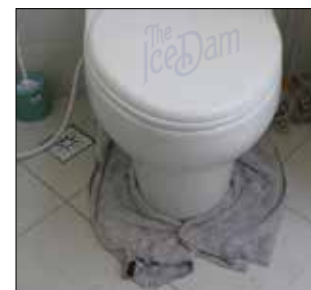
Is the leak in close proximity to a plumbing fixture, water supply or drain line? The most common sources of plumbing related leaks in homes are associated with failing shower pans, over-flowed bathtubs and faulty caulking or bad wax rings around toilets. Water can travel many feet from the source before it finds the path of least resistance and shows up. It's typical to see water coming through penetrations through the ceiling such as recessed lights and at sheetrock seams many feet from the leak source. Plumbing failures can occur at any time during the year. When they happen in the winter, homeowners often assume it is an ice dam. Plumbing leaks can be tricky to find and fix. Our favorite tool to find this type of leak is the thermal imager. This is a special camera that sees through walls and ceilings to detect differences in temperatures.

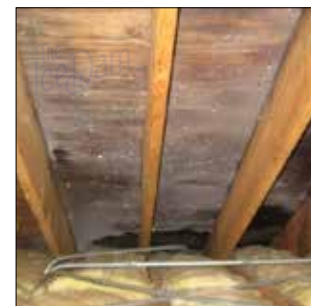
If possible, it can be tremendously helpful to peek into the attic. A healthy attic with good ventilation (Ice Dam Company Case #17) should not present moisture or frost on the framing members or roof decking. The photo, right, shows a poorly insulated, ventilated and air-sealed attic. Notice the frost on the underside of the roof decking? This is not good. Attic frost can cause tremendous damage and is most likely to accumulate when temps are quite low (below 10°F). Warm, moist air meets the ice-cold roof deck and freezes into frost. This cycle continues until as much as 1/8" to 1/2" of frost has built up. When outdoor temps rise above freezing, all of that frost melts and has nowhere else to go by the interior of the house. This type of 'leak' is tricky because it is actually not a leak. We have seen clients spend thousands of dollars trying to resolve a roof leak that was in fact nothing more than attic condensation. Future Ice Dam Company Case Studies will discuss how we fix this issue.
